**UNITED STATES  
NUCLEAR REGULATORY COMMISSION**  
REGION III  
2443 WARRENVILLE ROAD, SUITE 210  
LISLE, IL 60532-4352

EA-10-087

**SUBJECT: DAVIS-BESSE NUCLEAR POWER STATION SPECIAL INSPECTION TO  
REVIEW FLAWS IN THE CONTROL ROD DRIVE MECHANISM REACTOR  
VESSEL CLOSURE HEAD NOZZLE PENETRATIONS 05000346/2010-  
008(DRS) AND EXERCISE OF ENFORCEMENT DISCRETION**

Enclosure: Inspection Report 05000346/2010-008(DRS);  
w/Attachments: 1. Supplemental Information  
2. Chronology of Examinations  
3. Comparison of Examination Results  
4. Pictures- Examinations, Nozzle Repairs, and Flow Paths  
5. Davis-Besse Special Inspection Charter

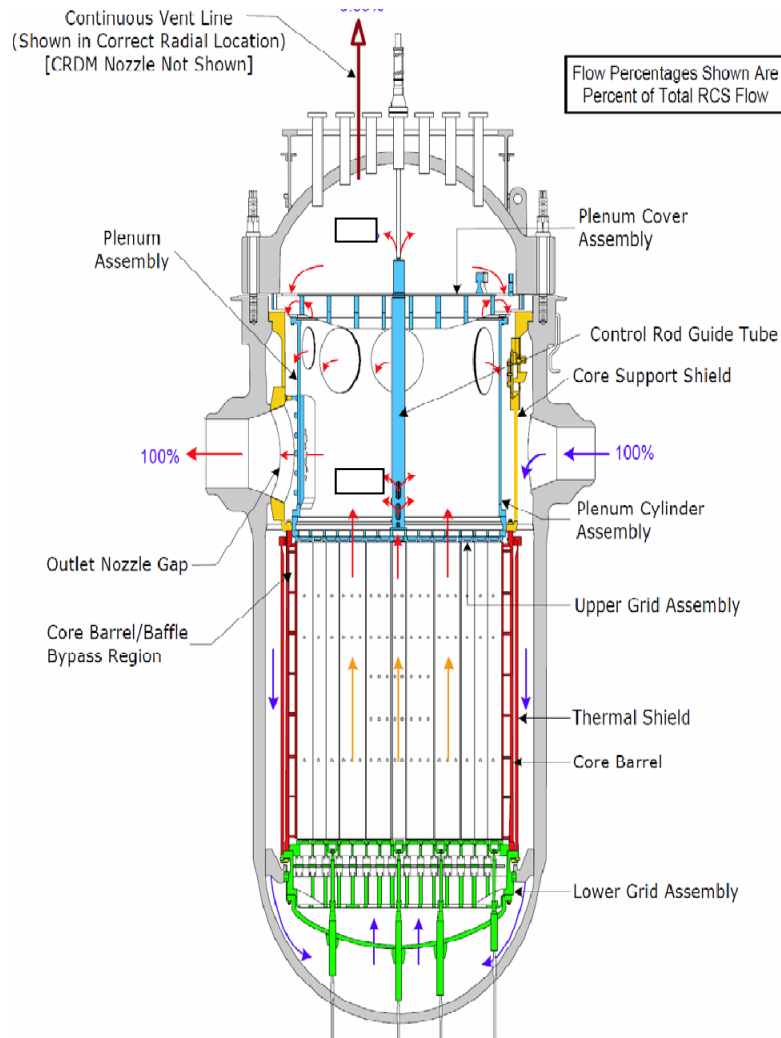
Picture No. 10 – Vessel Flow Paths

The licensee subsequently determined that channeling of water to the head directly from fuel assemblies located in core locations below the control rod guide tubes was responsible for the increased RVCH operating temperature. Specifically, for the Davis-Besse reactor design, the reactor coolant rises up through the reactor core to remove heat generated by the fuel assemblies. A plenum assembly with control rod guide tubes is located between the reactor core and the RVCH. The plenum assembly is designed to promote a more uniform radial pattern for reactor coolant exiting towards the RCS outlet nozzles. A portion of the total RCS flow proceeds up the control rod guide tube and exits directly into the upper RVCH region (Attachment 4, Picture No. 10). This flow then exits near the periphery of the plenum assembly. Because of this effect, the licensee developed a methodology for better estimating head operating temperature as documented in 51-9137401-000 "Evaluation of Fluid Temperature in DB RV Closure Head." This document estimated fluid temperatures within the RVCH region based on flow distributions, fluid temperatures from other analyses, operating data, and core design analyses. The RVCH head fluid temperatures derived from this calculation were higher than previously calculated due to the non-uniform mixing (channeling) of water exiting fuel assemblies in the core. Because document 51-9137401-000 relied extensively on engineering judgment to estimate internal vessel flowrates as inputs in calculation of fluid temperatures within the head, it was subject to an undefined level of uncertainty. To bound the uncertainty in using this method to derive a "best estimate" of the RVCH operating temperature, the licensee elected to use the highest temperature
